SERVICE NEWS

Vol. 8, No. 3, July -September 1981
CONTENTS

Aft Cargo Door Uplock Binding

Adjusting Landing Lights

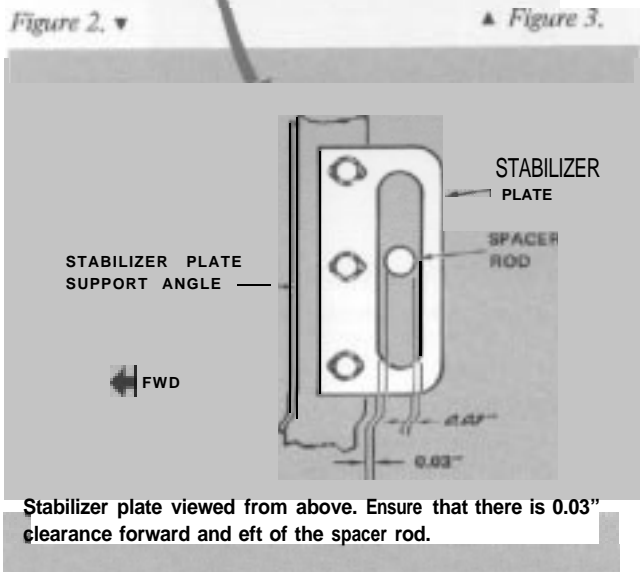
To determine whether or not the uplock support angles need to be changed, check the relationship between the spacer rod, located on the forward side of the uplock assembly, and the stabilizer plate (P/N 374512-1) which is attached to the fuselage station 847 canted bulkhead. With no outside load applied, the clearance between the spacer rod and the stabilizer plate must be at least 0.03 of an inch on both the forward and aft sides of the rod (Figure 2).

Stabilizer plate viewed from above. Ensure that there is 0.03" clearance forward and aft of the spacer rod.

If you find that there is insufficient clearance, or that the spacer rod and stabilizer plate are actually touching, attempt to correct the problem by adjusting the 374512-1 stabilizer plate. This is done by loosening the three NAS623-3-7 screws which attach the stabilizer plate to the fuselage station 847 canted bulkhead. Slide the

stabilizer plate forward or aft, as necessary, to obtain the appropriate clearance. Then tighten the screws. If the correct clearance cannot be obtained, or if the spacer rod strikes the adjacent structure (the stabilizer plate support angle), the two uplock support angles are probably misaligned. Make the following check to determine whether they are in fact misaligned:
