VOL. 8, NO. 4, OCTOBER - DECEMBER 1981

LOCKHEED-GEORGIA COMPANY A DIVISION OF LOCKHEED CORPORATION

Troubleshooting Pressurization Problems

Circuit Breakers

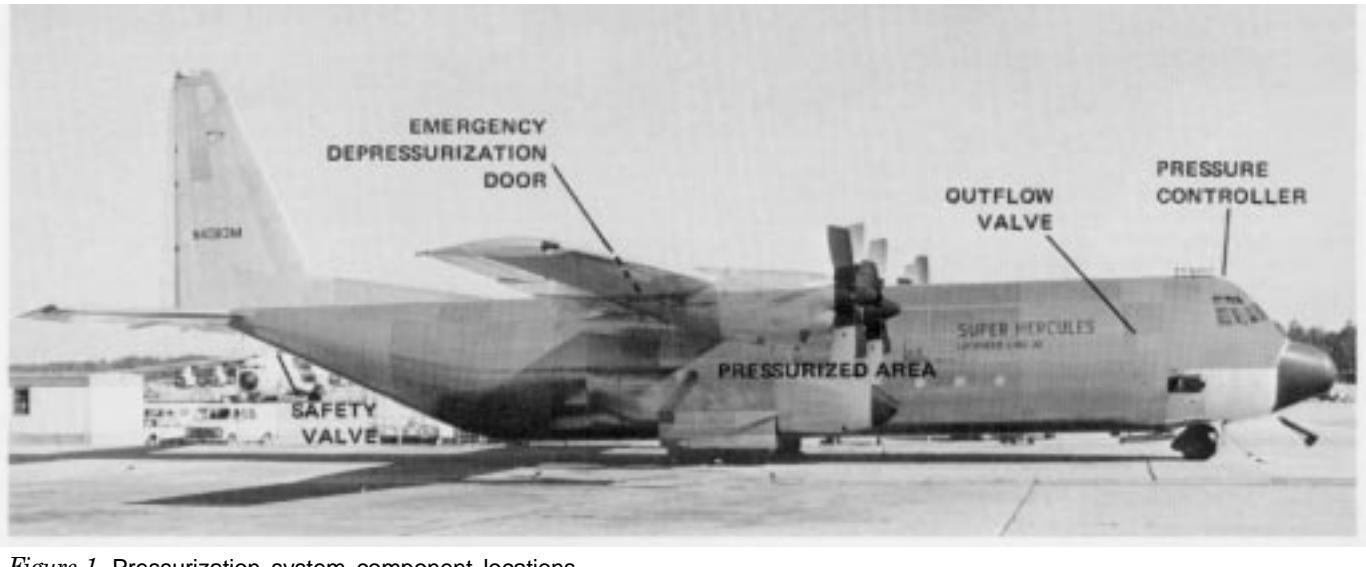
Figure 1. Pressurization system component locations.

One of the first questions to ask is: Can pressurization be obtained in the MANUAL mode but not in the AUTO mode? If the answer is yes, the problem is trouble in the cabin pressure control equipment, not an inadequate air supply. The following troubleshooting procedure may be used to help you isolate a defective pressure controller or outflow valve (Figure 1).

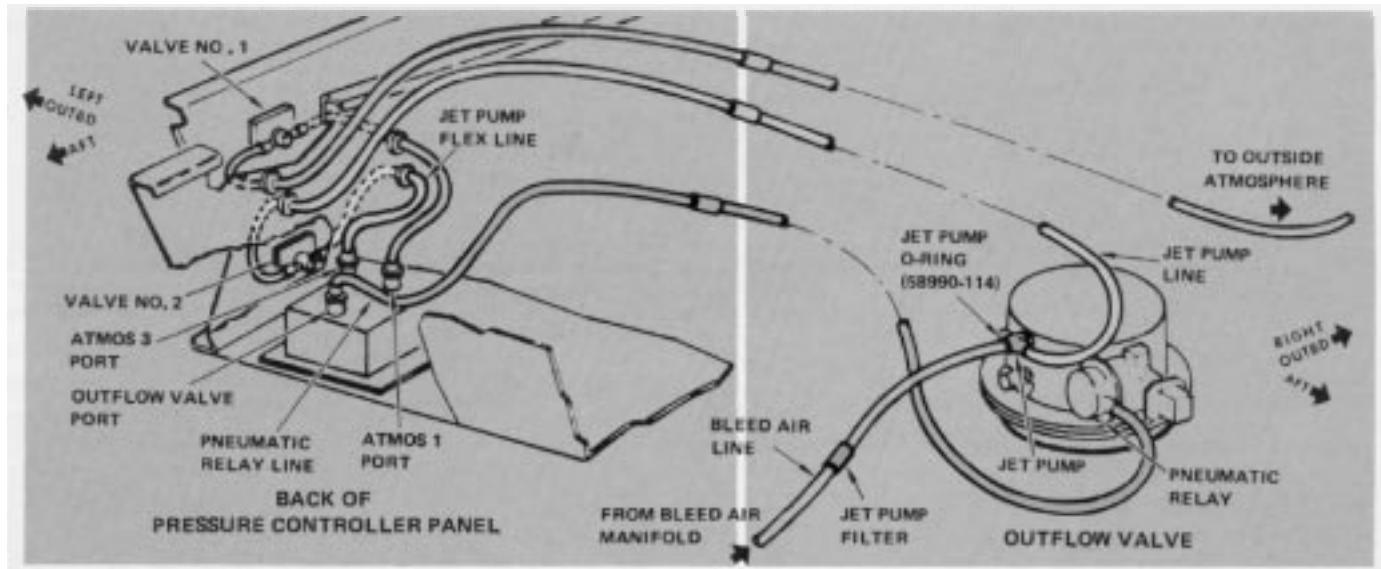
Figure 2. Cabin pressurization control components.

7. Disconnect the pneumatic relay line from the OUT-FLOW VALVE port at the back of the pressure controller and attach the vacuum gage to the OUTFLOW VALVE fitting on the pressure controller (Figure 2).

9. Check the vacuum gage. If the gage indicates 0.4 in. Hg or less, proceed to Step 10. If the gage indicates 0.5 in. Hg or greater, replace the pressure controller.

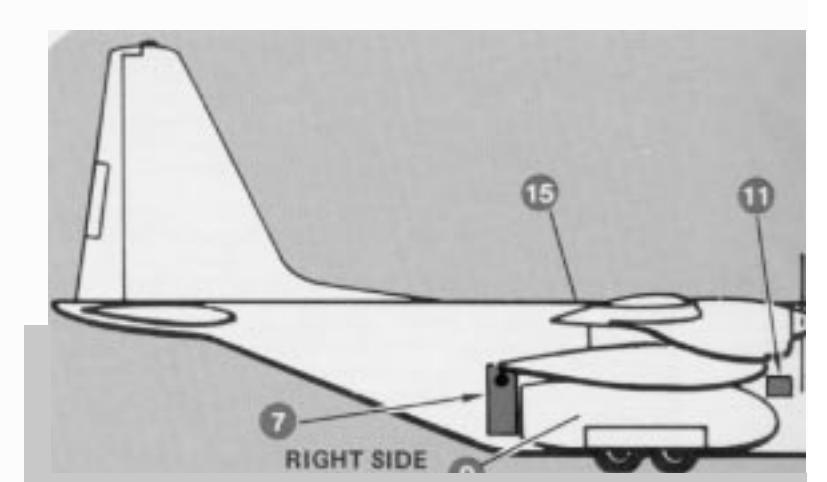
INDEX NO.	NOMENCLATURE	LEAK POINTS
1	Aft cargo ramp	Seal assembly
2	Aft cargo door	Seal assembly
3	Crew entrance door	Seal
4	Safety valve	+ Butterfly Valve
5	Outflow valve	*Butterfly valve
6	Flapper valve	seals
7	Paratroop door (2 ea)	Seal assembly
8	Elevator. rudder push pull rods	Seal assembly and boot assembly
9	MLG inspection windows 14 ea) MLG access doors 14 ea) MLG attach structure	Seals Seals Sealant and fasteners
10	Fwd, center, and ah emergency exits	Seals
11	Side emergency exit	Seals
12	Swing windows	Seal assembly
13	ADF radome	Sealant and fasteners
14	Doppler radome	Sealant and fasteners
15	Life raft cables. aileron push pull rods, and flap torque tube	Seals
16	Nose wheel well diaphragm coven (3 eal	Saab
17	NLG inspection window and door	Seal assembly
19	Pyrotechnic pistol door	Seal assembly
19	Center wing dry bay	Cracks, duck. and conduit sealant
20	Upper recirculation duct and flapper check valve	Cracks

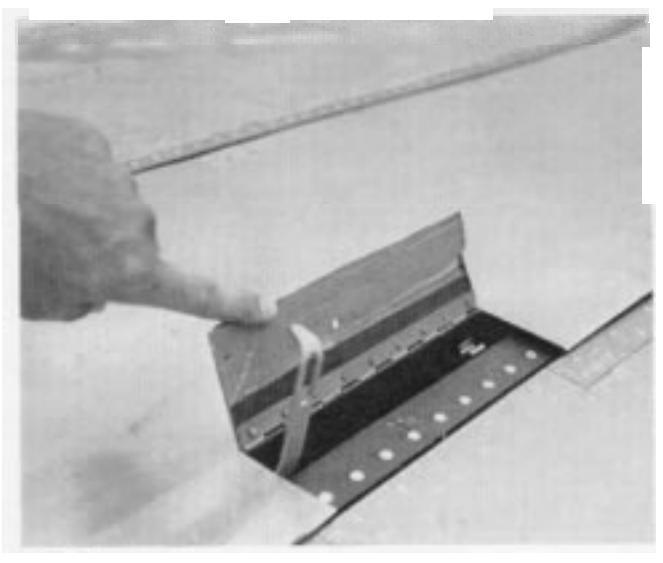
Latch release handle access door and handle.

The springs on the latch release handle access door assembly can become weakened through vibration, corrosion, and age. The same factors can also affect the door hinges. As the springs weaken, the access door acquires a tendency to flutter, especially during propeller reversal. With weak or broken springs and excessive hinge corrosion, the suction created by propeller reversing could conceivably pull the access door loose.

Modification Procedure
