Lockheed

SERVICE NEWS

VOL. 10, NO. 4, OCTOBER-DECEMBER 1983

New Heat Exchangers for the Hercules Aircraft

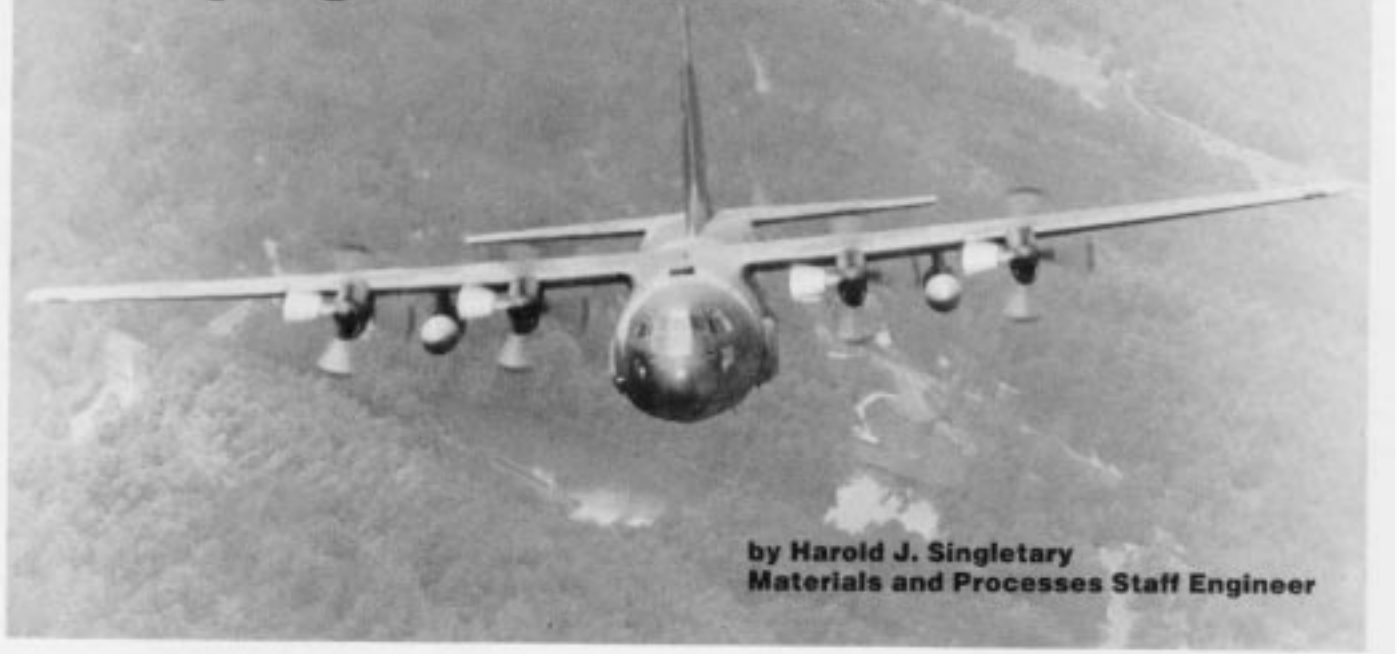
Keeping the Front Beam Clean

Soot is one of the constituents of the engine exhaust of the Hercules aircraft. It consists largely of carbon particles, but it also contains a variety of chemical compounds, including sulfur compounds. This combination has a significant potential for inducing corrosion, and soot will in fact cause damage if it is allowed to remain in contact with aluminum aircraft structure.

On exterior surfaces, soot is visible and can be washed away, if it is not embedded into the paint. When soot penetrates to interior surfaces, such as it can do particularly during engine thrust reversal, it is not so easily seen or dislodged. One such area is inside the leading edge of the Hercules aircraft outer wing.

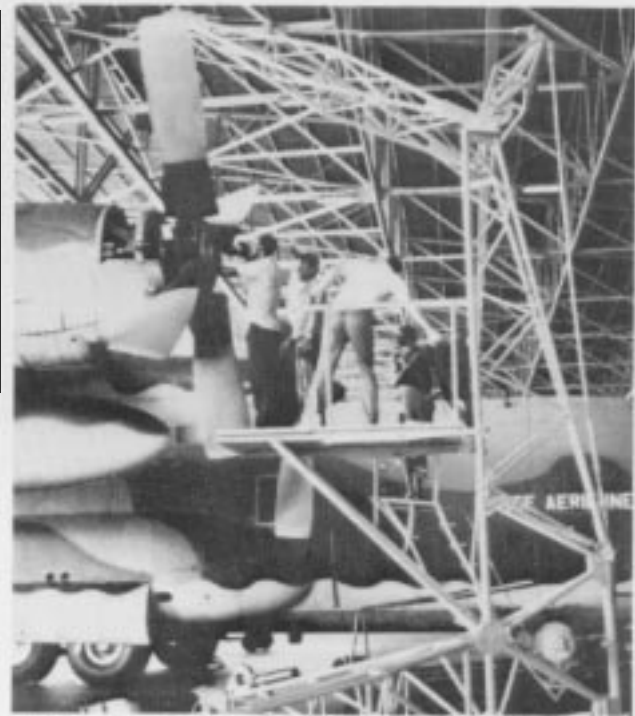
Prop Removal and Installation Aid

Anyone who has removed and installed Hercules aircraft propellers using a Type J-1B Portable Engine or Turret Crane, specification MIL-C-6497, or similarly designed cranes, knows that one of the difficulties that is often encountered is getting close enough to your work. Because of the design of the J-1B crane, positioning B-5 stands close enough to the propeller to work safely and with any degree of convenience can be difficult. By modifying an extra J-1B crane that happened to be on hand, one of our operators found that removing and installing propellers could be done with much more efficiency and convenience.

We thought that what this operator accomplished would be interesting to our readers and we are grateful to Loreto Gordoncillo of FAZA, the Republic of Zaire, and Fred Beach, Lockheed Field Service Representative, for sharing the details with us. In considering this modification, the reader should be aware that Lockheed engineering has not evaluated the changes described from the standpoint of any possible effects on the structural strength or safety of the affected equipment, nor has such a modification been attempted at Lockheed. We are passing the information along as a matter of interest only.
