VOL. 29, NO.1, 2004

Service News

SPECIAL CORROSION ISSUE

A SERVICE PUBLICATION OF LOCKHEED MARTIN AIR MOBILITY SUPPORT

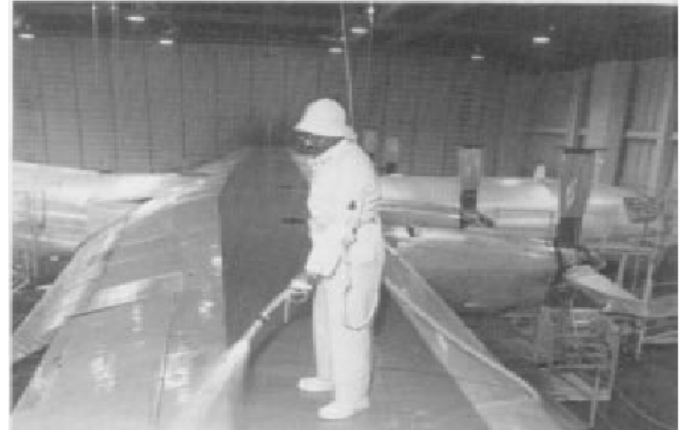
Wash rack workers need the protection of safety harnesses when working on the upper surfaces of the aircraft.

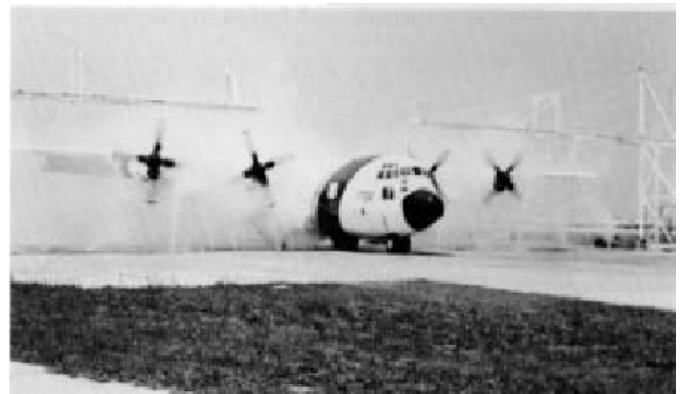
An automated outdoor rinsing facility helps protect Coast Guard aircraft from the corrosive effects of salt spray.

Rinse water pressure is not as important as the volume of water. As a rule of thumb, adequate pressure is available when the top of the tail can be rinsed by a worker standing on the ground. The volume of water used should be sufficient to provide a free-flowing action over the surface being rinsed; this requires a minimum flow of about eight gallons per minute.

Water quality is also important for washing and rinsing airplanes. In some parts of the world, the local water is not suitable for cleaning because of its “hardness.” Hardness is a general term used to describe the amount of dissolved minerals, primarily calcium carbonate (CaCO_3), that water may contain. Total hardness or CaCO_3 should be limited to 420 parts per million (ppm). In addition, total dissolved solids should be limited to 500 ppm, sulfate to 107 ppm, and chloride to 50 ppm. Water containing less than these limits is considered satisfactory for washing aircraft. When water analysis indicates values significantly in excess of those listed, the water should be chemically treated to reduce the level of impurities before it is used to wash an airplane.

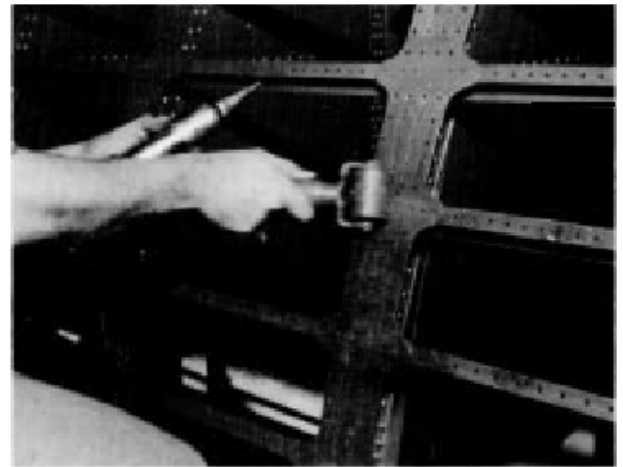
The use of sealants during aircraft manufacture has proved an effective and versatile weapon against corrosion.

Sealant may be the most versatile and effective weapon in preventing aircraft corrosion ever introduced. It is used to exclude moisture and water and to separate joined metals. Exterior joints and gaps are filled with sealants to prevent water and chemicals from entering. In addition to environmental sealing, sealant is also used for wet-installation of fasteners, pressure sealing, and aerodynamic smoothness.

The use of sealant, specifically to combat corrosion in the Hercules aircraft, started with the manufacture of Lockheed Martin serial number 4127 in May 1965. At first, a non-corrosion inhibiting sealant of the MIL-S-8802 type was employed. Beginning with LM serial number 4331, built in September 1968, a corrosion inhibiting sealant conforming to MIL-S-81733 was introduced.
