SERVICE NEWS

Vol. 8, No. 3, July -September 1981
CONTENTS

Aft Cargo Door Uplock Binding

Adjusting Landing Lights

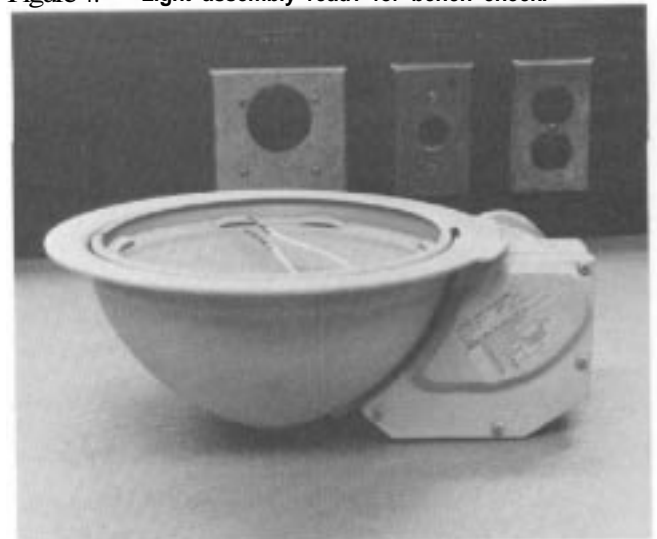
Figure 4. Light assembly ready for bench check.

Place the landing light assembly on a workbench, as shown in Figure 4.
