VOL. 8, NO. 4, OCTOBER - DECEMBER 1981

LOCKHEED-GEORGIA COMPANY A DIVISION OF LOCKHEED CORPORATION

Troubleshooting Pressurization Problems

Circuit Breakers

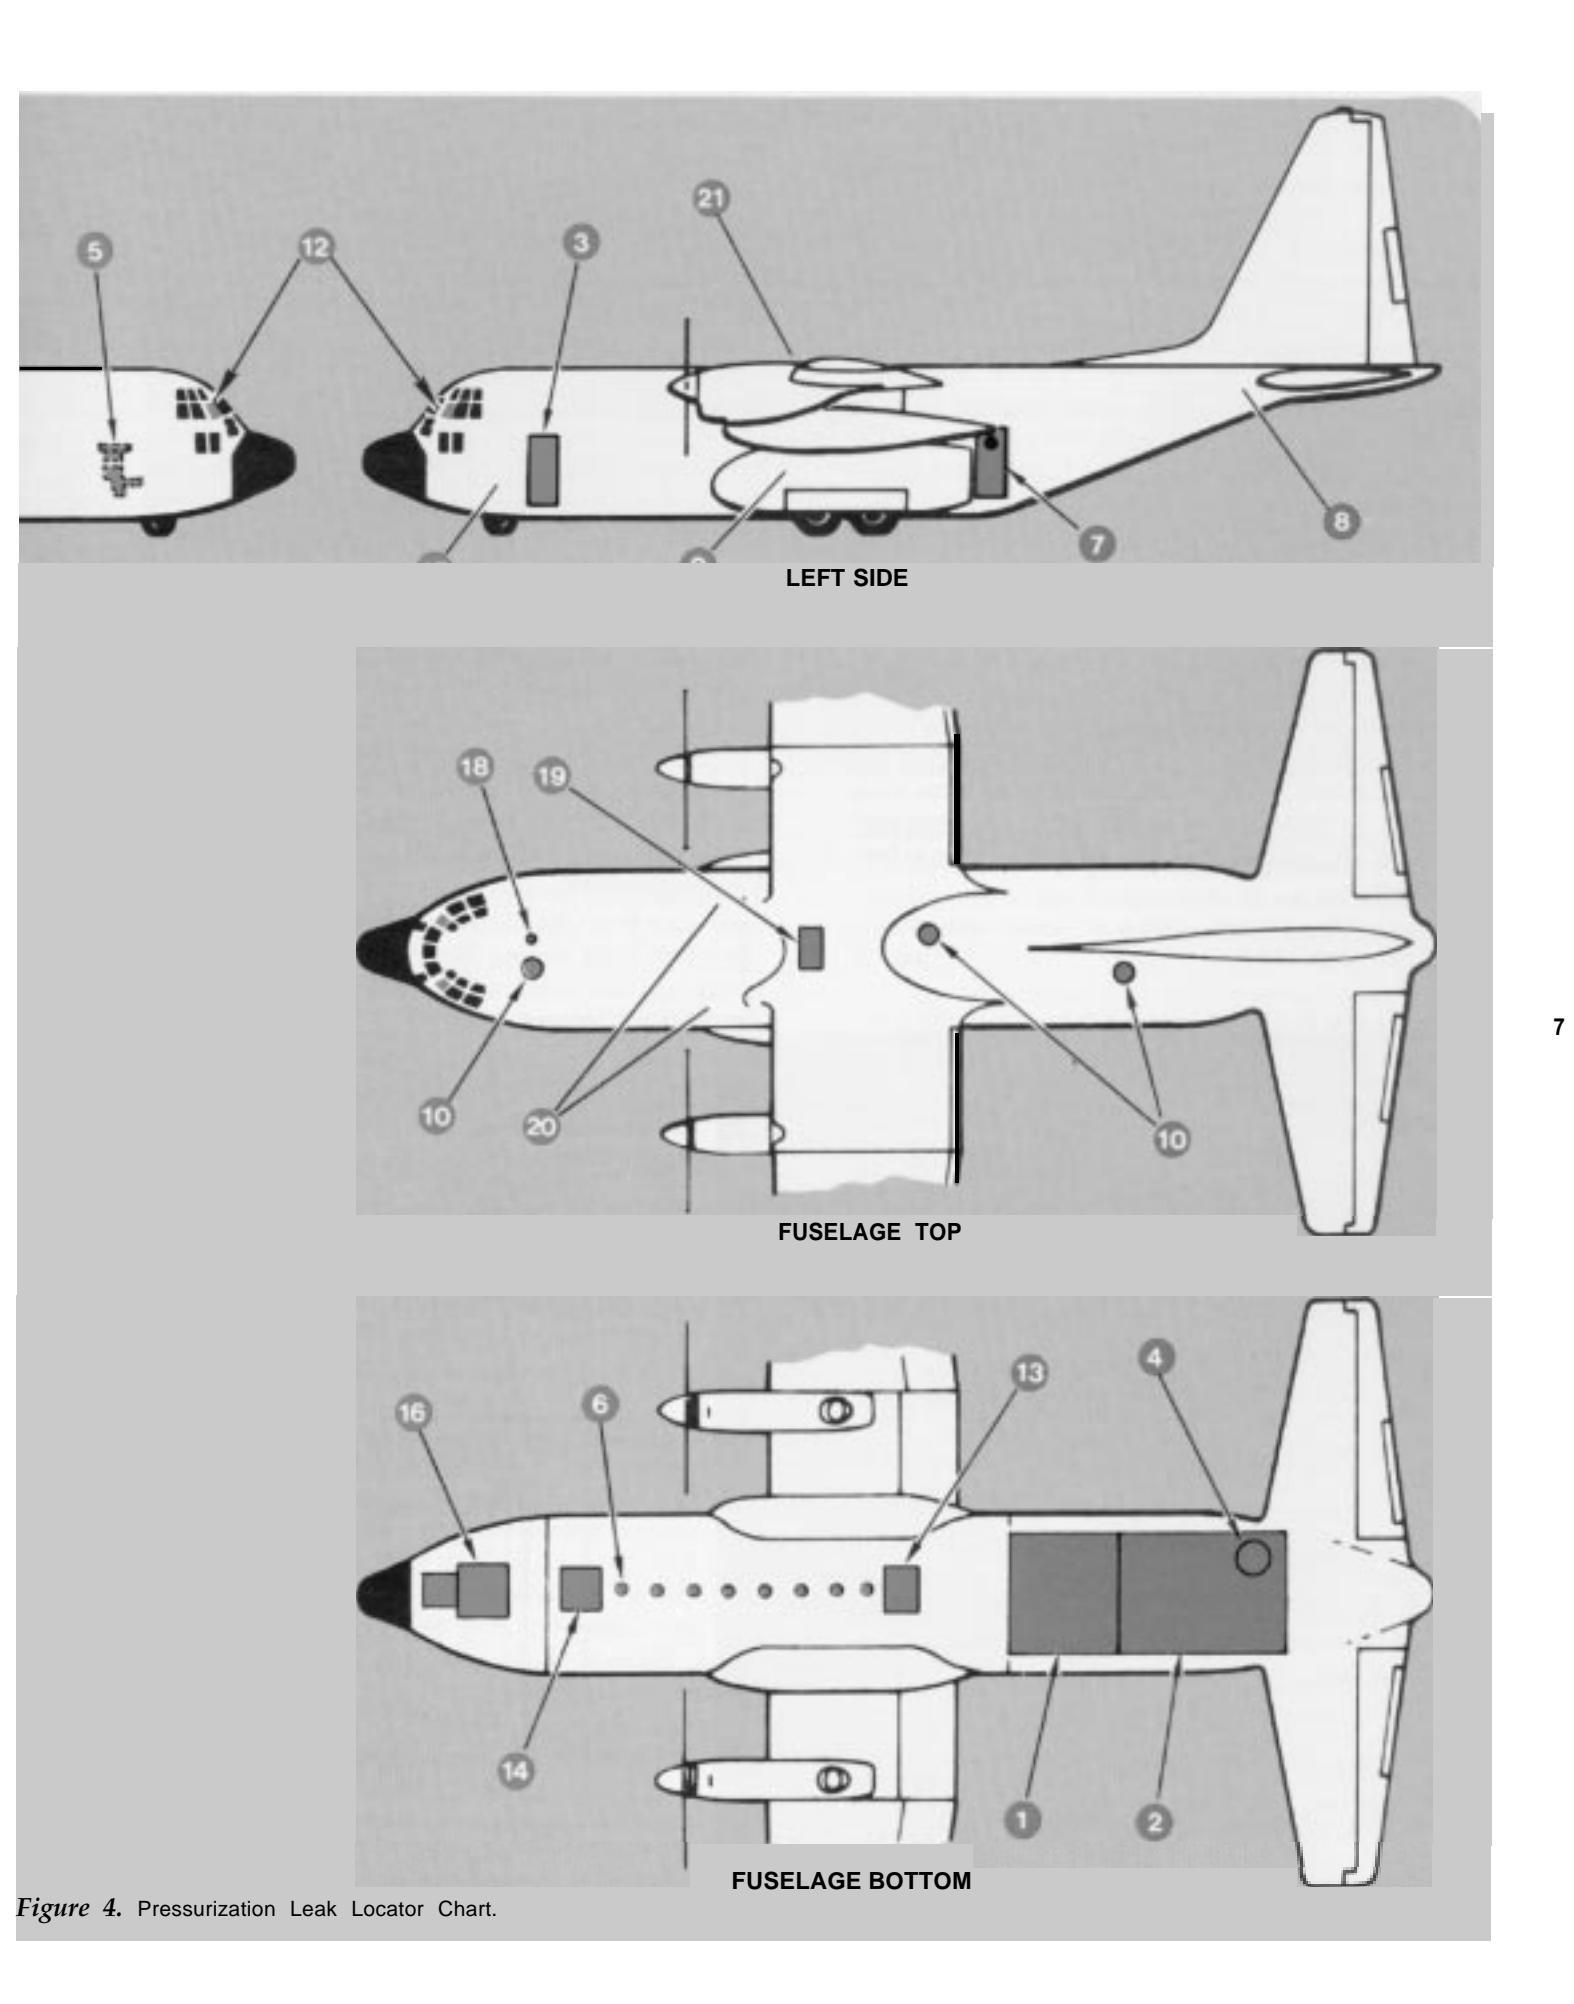
If the timed pressure decay leakage test is unsatisfactory, the cabin is leaking excessively. To find where the leaks are, pressurize the aircraft to 2 to 3 in. Hg (0.98 to 1.47 psi) and inspect the fuselage door seals, exterior surfaces, and joints. Leaks can be located by feel or by using an approved liquid leak detector or soapy solution. Figure 4 shows those areas of the Hercules aircraft which tend to leak most often. In the table, these areas are listed in the approximate order of their susceptibility to the kinds of wear and damage that can result in pressure leakage problems. A systematic approach to finding a pressure leak in an unknown location would be simply to start at the top of the list and work down.

INDEX NO.	NOMENCLATURE	LEAK POINTS
1	Aft cargo ramp	Seal assembly
2	Aft cargo door	Seal assembly
3	Crew entrance door	Seal
4	Safety valve	+ Butterfly Valve
5	Outflow valve	*Butterfly valve
6	Flapper valve	seals
7	Paratroop door (2 ea)	Seal assembly
8	Elevator. rudder push pull rods	Seal assembly and boot assembly
9	MLG inspection windows 14 ea) MLG access doors 14 ea) MLG attach structure	Seals Seals Sealant and fasteners
10	Fwd, center, and ah emergency exits	Seals
11	Side emergency exit	Seals
12	Swing windows	Seal assembly
13	ADF radome	Sealant and fasteners
14	Doppler radome	Sealant and fasteners
15	Life raft cables. aileron push pull rods, and flap torque tube	Seals
16	Nose wheel well diaphragm coven (3 eal	Saab
17	NLG inspection window and door	Seal assembly
19	Pyrotechnic pistol door	Seal assembly
19	Center wing dry bay	Cracks, duck. and conduit sealant
20	Upper recirculation duct and flapper check valve	Cracks

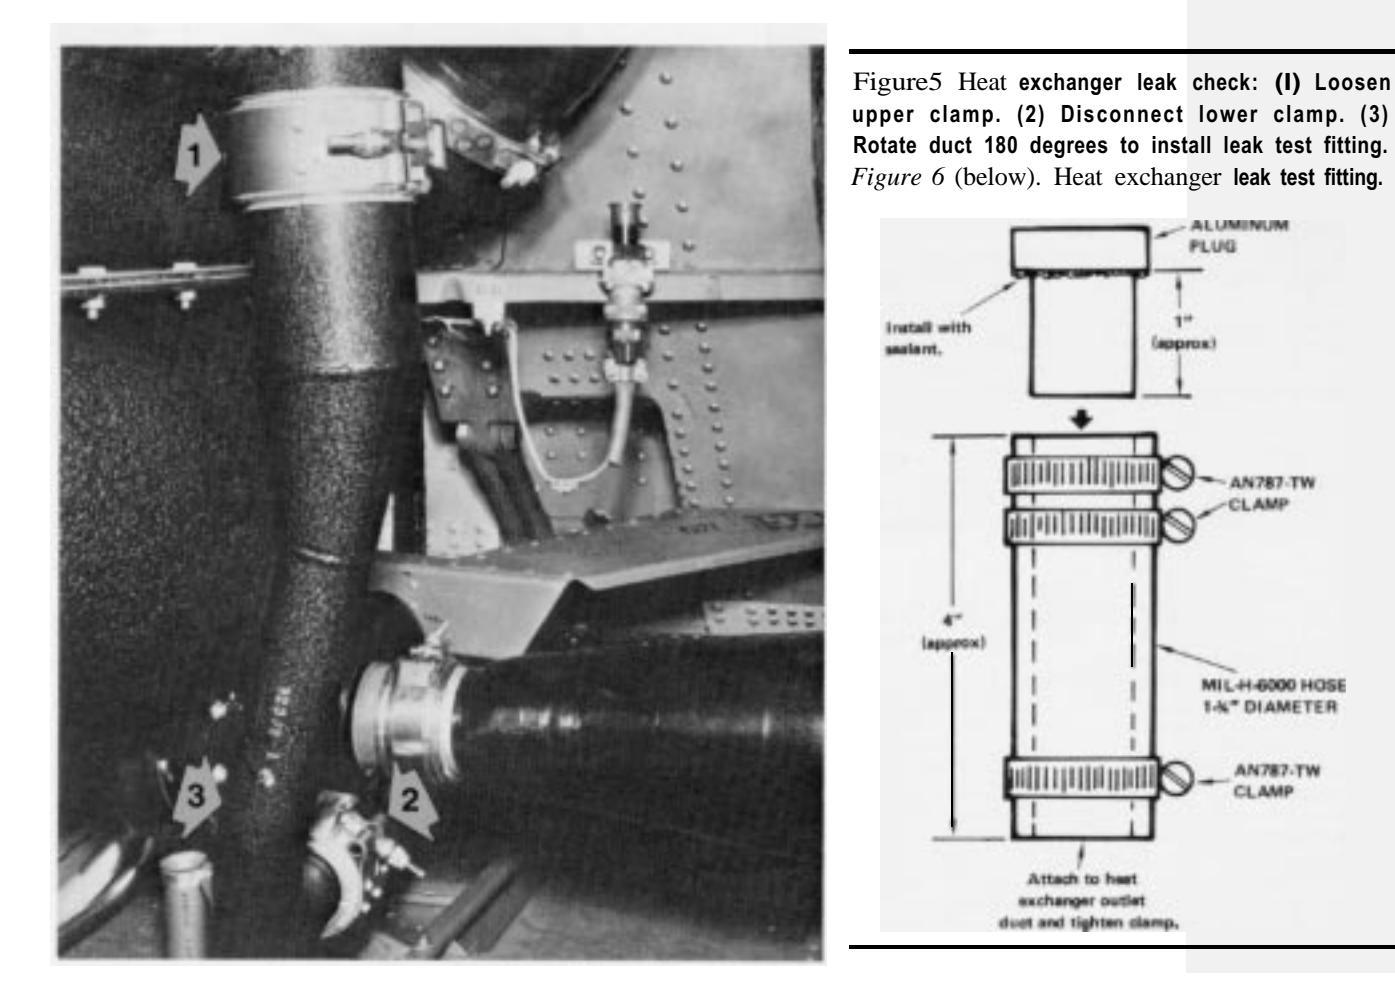
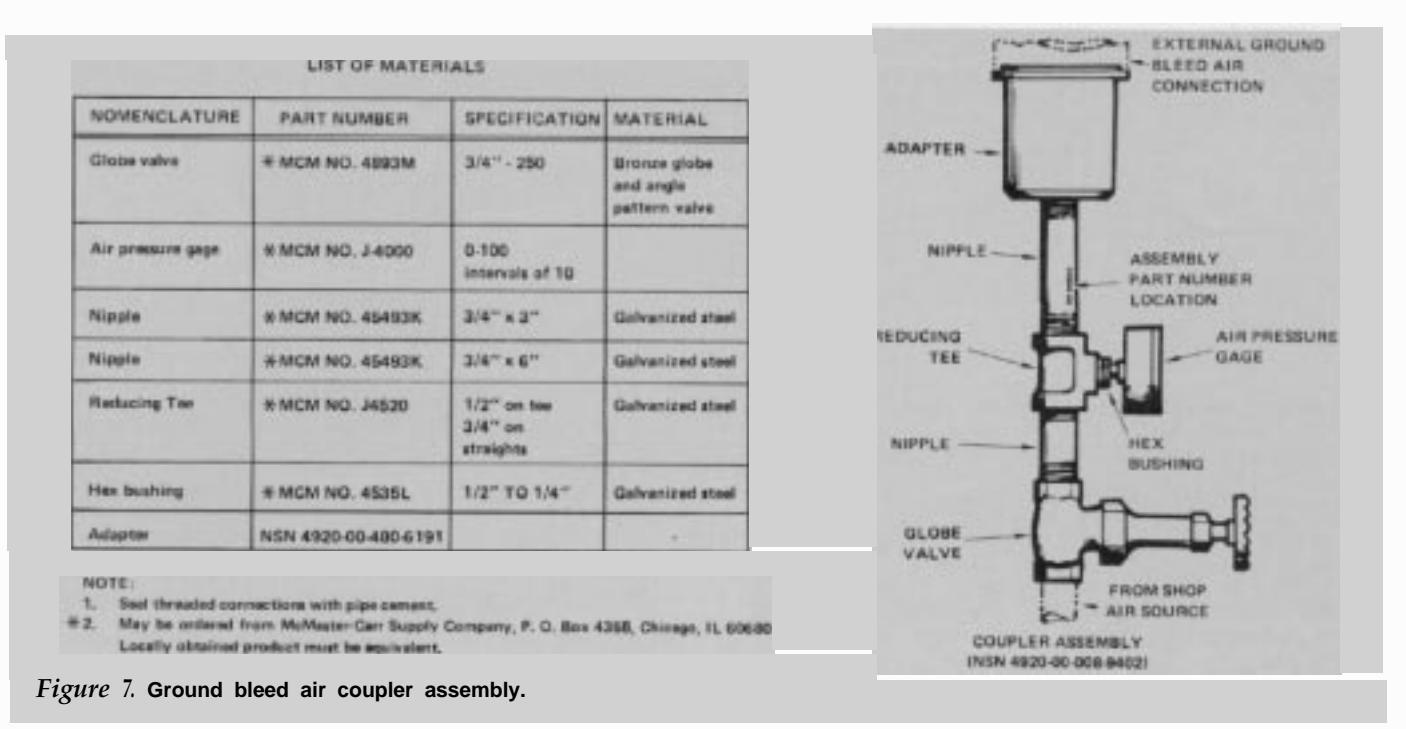
1. Disconnect the duct between the heat exchanger and the turbine and cap the end of the duct from the heat exchanger (Figure 5), using a locally manufactured leak test fitting (Figure 6).

3. Check for leaks by feeling for the presence of escaping hot air in the air intake scoop or exhaust. Leaks are very evident when they exist. Replace the heat exchanger if leaking is evident.
