Service news

A Service Publication of Lockheed Aeronautical Systems Company

Plugs and Covers for Your Hercules

Generator Control Unit 0 0 0 0 Truth Table Monitoring

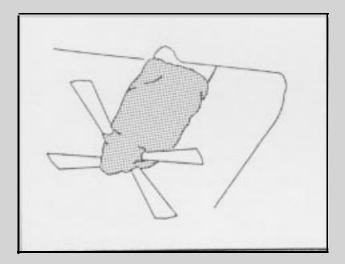
Propeller Spinner and Engine Nacelle Cover

The PN 404100-1 Spinner and Nacelle Cover (shown above) is a protective device designed for use in particularly harsh environments. It is made of weather and sunlight-resistant vinyl fabric.

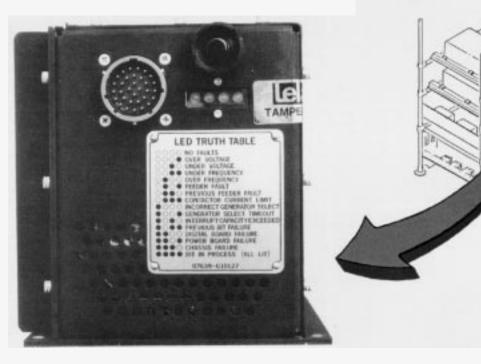
H ercules aircraft beginning with Lockheed serial number LAC 527 1 are equipped with new generator control units (GCUs), PN 697856-1. Individual GCUs replace the ensemble of components-voltage regulator, generator control or protection panel, and frequency-sensitive relay-thatwerepreviouslyrequired to control each of the aircraft's engine-driven generators and the APU generator.
